# RELEASE OF ASBESTOS FIBRES IN SYSTEM BUILT SCHOOLS

Michael Lees

**Part 1** 20<sup>th</sup> February 2008. AL 4 15<sup>th</sup> June 2008

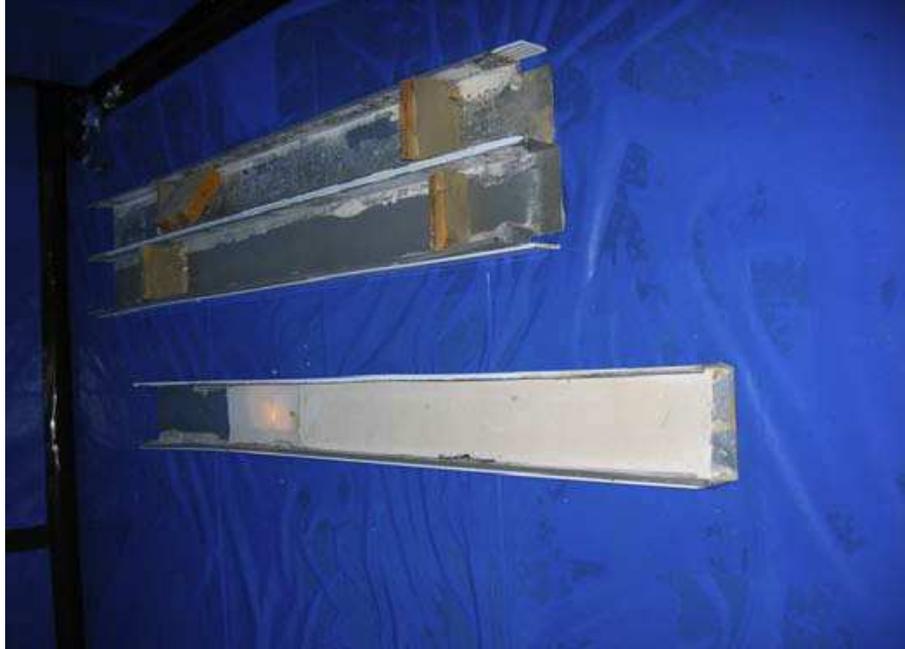
### **Plate 3: Metal Casing Removed**

Note: AIB glued to casing in bottom of photograph. AIB has been removed at some time from the top two casings leaving behind asbestos debris.

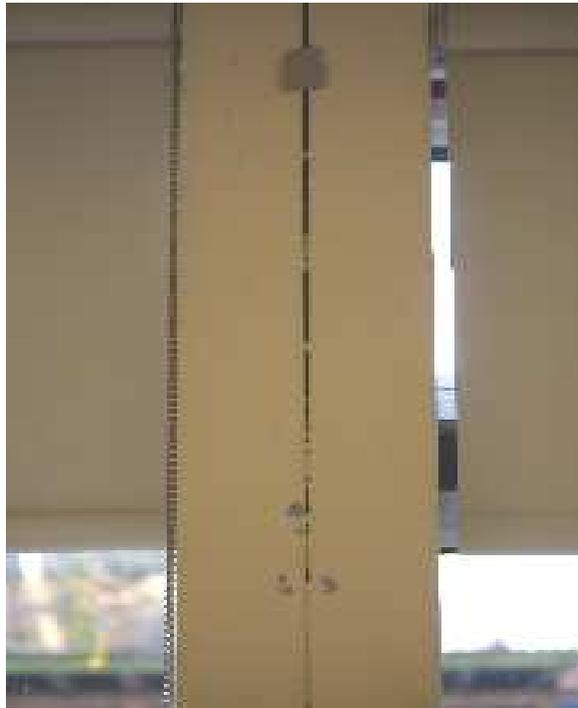
### **Plate 4: Crack in Column Casing**

consequently the gap allows asbestos fibres to be forcibly ejected when the column is knocked. As there is a gap in the front it is probable that there is a similar gap in the back, however this cannot be examined as the casing in this case was about 5mm from the window frame.

Note: Any asbestos fibres can be readily released through this gap. It is probable that a similar gap is also behind the column adjacent to the window frame.

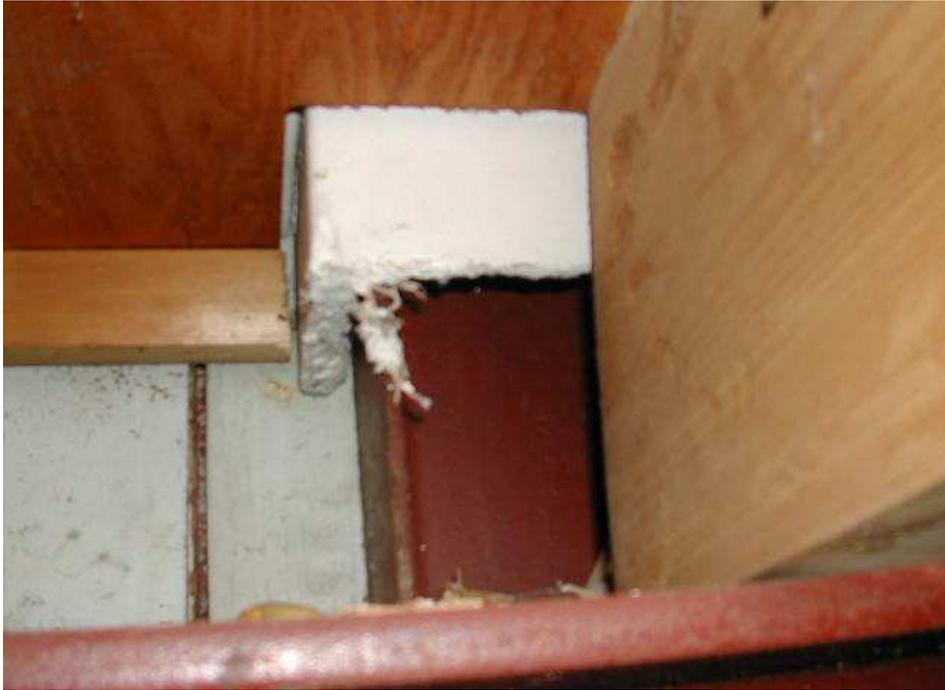
**Plate 5: Exposed badly damaged asbestos cladding**

Note: It appears that the asbestos cladding has been cut when fitting the shelves. This would release large amounts of asbestos fibres. It is possible that this is moulded cladding.

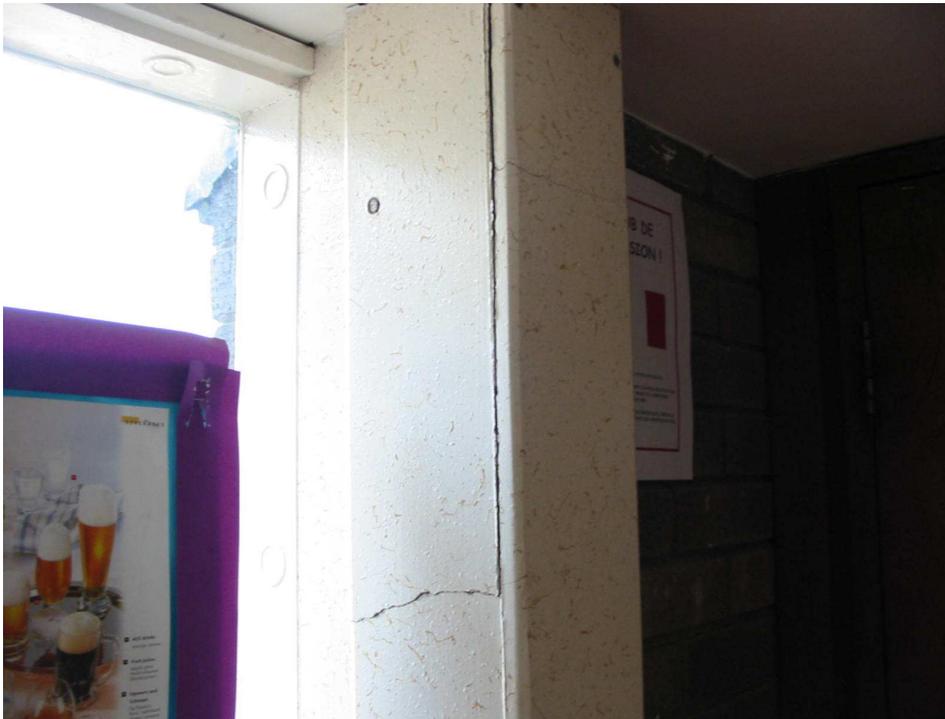
**Plate 6: Damaged cladding.**

Note: It is also possible that this is moulded cladding. It is badly damaged.

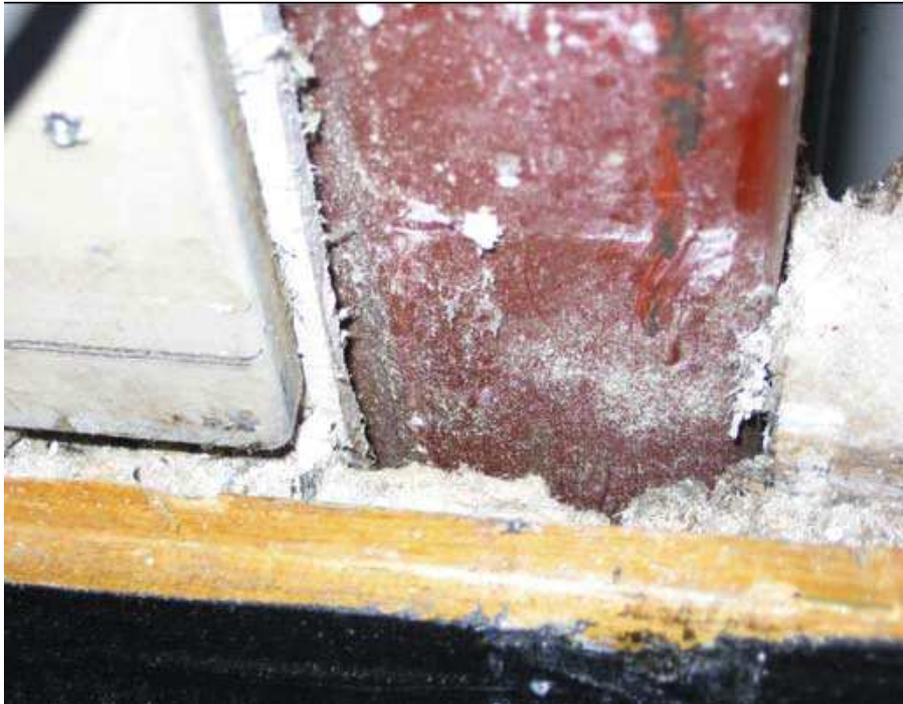
**Plate 7: Base of Column. Large Amount of Friable AIB Debris**

Plate 7 shows the base of a column where one half of the cladding has been removed. Large amounts of asbestos debris and fibres have accumulated over the years. It should be noted that there is a gap between the base of the metal cladding and the skirting board so that asbestos fibres would have been readily ejected whenever the column was knocked.

Note: One half of the metal casing and AIB cladding has been removed. There is a gap between the bottom of the metal casing and the skirting board. The white fluffy material is amosite debris.

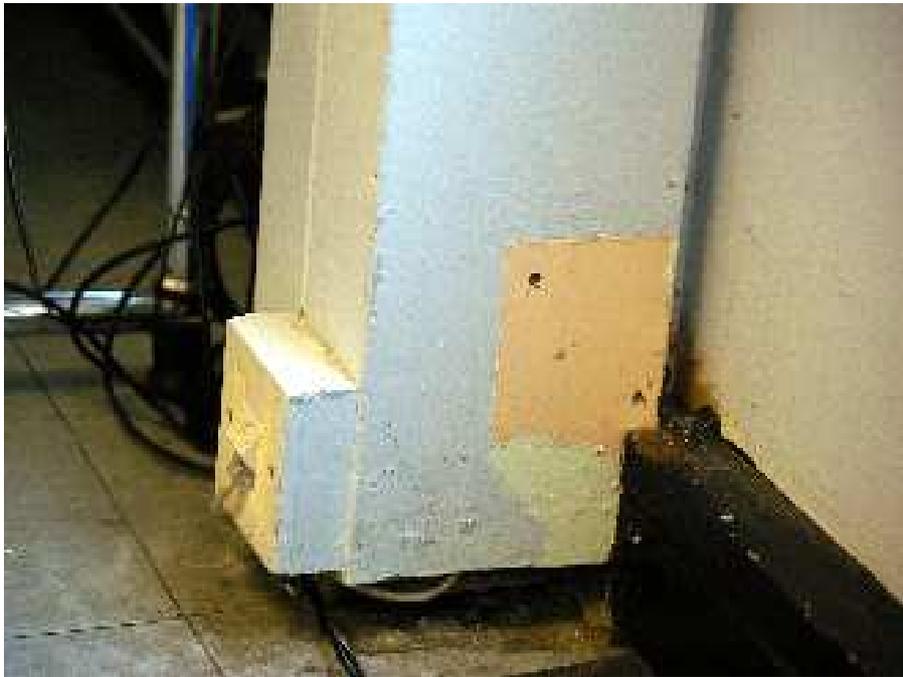
### Plate 8: Base of Column Casing.

44. Plate 8 shows the bottom of the metal casing, it and the cladding finishes about an inch and a half above the floor. The gap between the column and the cladding is an open void so that any asbestos fibres would not have accumulated over the years, instead they would have dispersed freely into the classroom. The telephone socket has been screwed onto the side of the casing into the cladding. The open screw holes can be clearly seen where the socket has been moved. Anything fastened with screws through the asbestos cladding is liable to cause release of fibres. HSE and HSL state:

Note: No Skirting. Socket Fastened to Casing. Gap between wall and back of casing. Open screw holes where socket has been removed

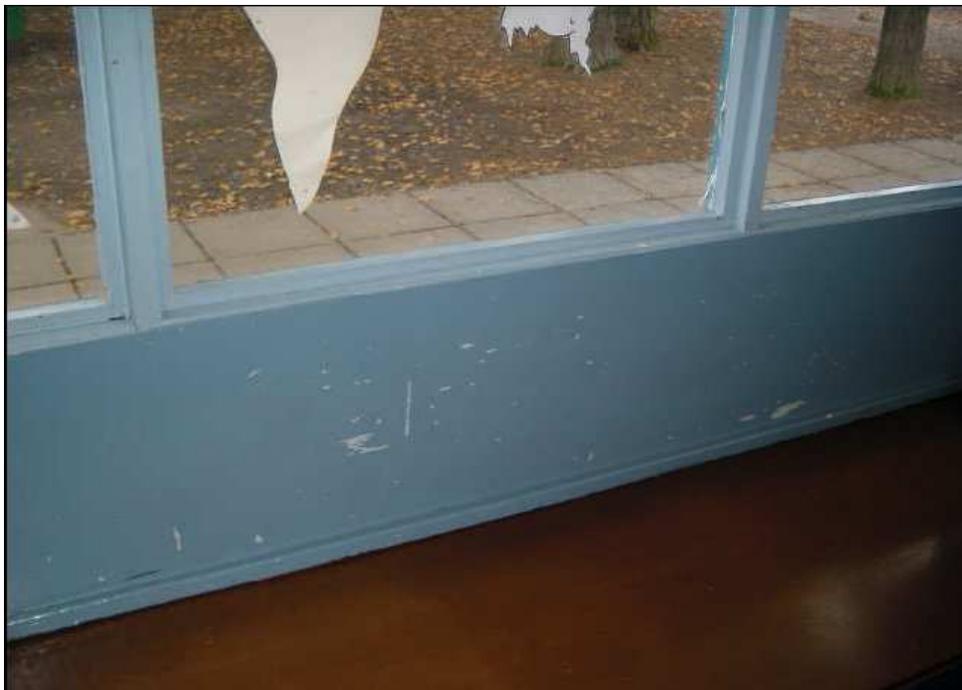
#### **Plate 9: Interior AIB Window Infill Panel**

Note: Some infill panels are a sandwich construction with two layers of AIB. Where the skirting board abuts the floor it is unlikely to provide an effective seal to asbestos fibres in the void. In addition the panel is scuffed .

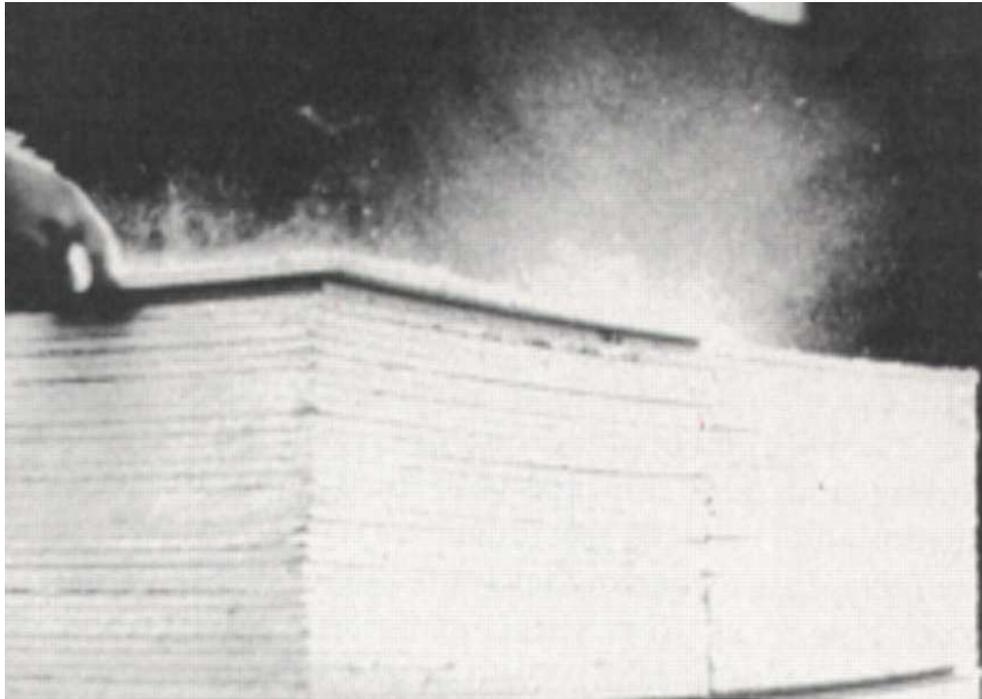
### **Plate 10: Cloud of Asbestos Fibres**

Note: Tyndall beam photography shows a cloud of mainly amosite fibres from stacking AIB panels. Each time AIB is hit the unsealed reverse face releases asbestos fibres.

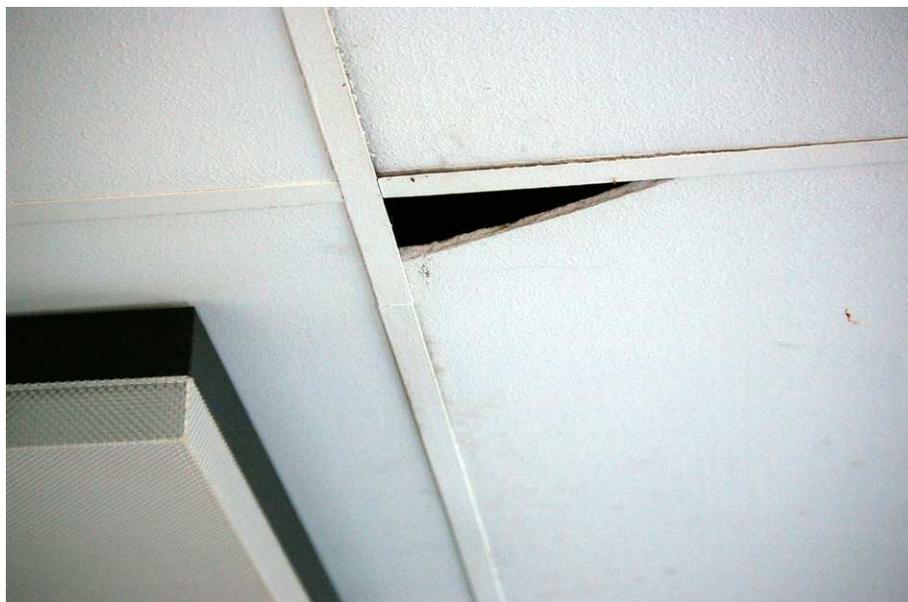
### **Plate 11: AIB Ceiling Tiles in a Classroom**

58. Plate 11 shows ceiling tiles in a metal grid in the suspended ceiling of a classroom. The tile is broken and a draught of air could be felt coming down through the hole, any asbestos fibres would have filtered down into the classroom. What should also be noted is that the adjacent tile is ill-fitting, so that if any asbestos fibres were on top of the tiles they would filter between the tile and the grid. In the same school many tiles had far larger gaps between the tile and the grid, some tiles were missing, others non-asbestos tiles were badly broken or sagging under the weight of water damage. As well as damaging the more friable asbestos materials a leak will allow the asbestos fibres to be suspended in the water to drip into the room beneath. When it finally dries out the fine asbestos fibres are left so that they can become suspended when disturbed.

Note: Broken AIB. Asbestos fibres will be also filter from around the ill-fitting ceiling tile. A draught could be felt from the hole, asbestos fibres would have entered the classroom.

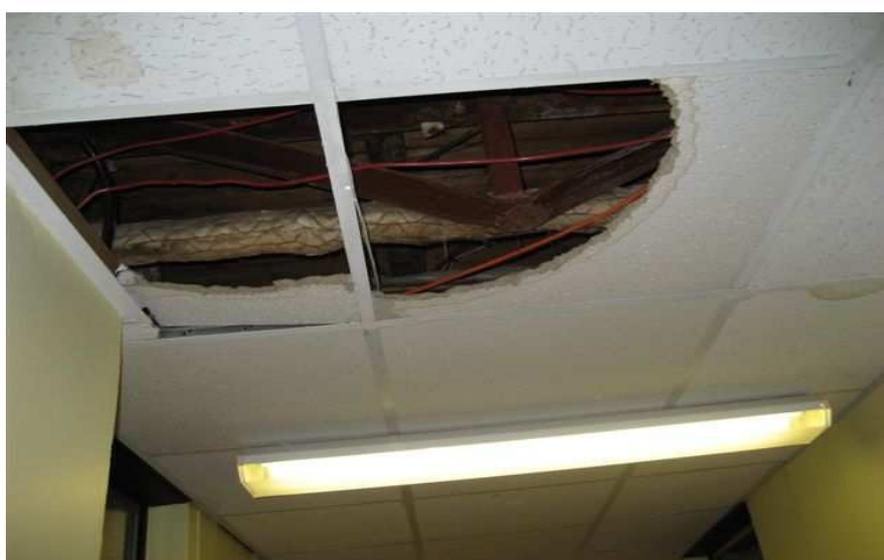
### **Plate 12: Badly damaged ceiling tile in school corridor**

59. See plate 12 for an example of badly damaged tiles in a corridor. Air sampling had proved that there is asbestos contamination in the ceiling void. This photograph was taken after remediation and after the contractor had declared the school safe for re-occupation. HSE had also carried out an inspection and agreed that remediation was complete and the school safe for re-occupation.<sup>38</sup> They are wrong, for as well as allowing asbestos fibres to enter the corridor, the fire integrity of the ceiling is lost. In some classrooms tiles had been lifted to suspend Christmas decorations from the metal grid. All these processes would allow the ingress into the classrooms of any asbestos fibres resting on the top surface of the tiles, whether they were AIB tiles or not.

Note: This is a CLASP Mk4 school. It is known that the ceiling voids are contaminated with asbestos. Although these tiles were not AIB, any fibres in the void would readily enter the corridor. In addition some of the other tiles are not firmly seated on the grid. Note this photograph was taken after remediation. The contractors and HSE declared the school safe for reoccupation.

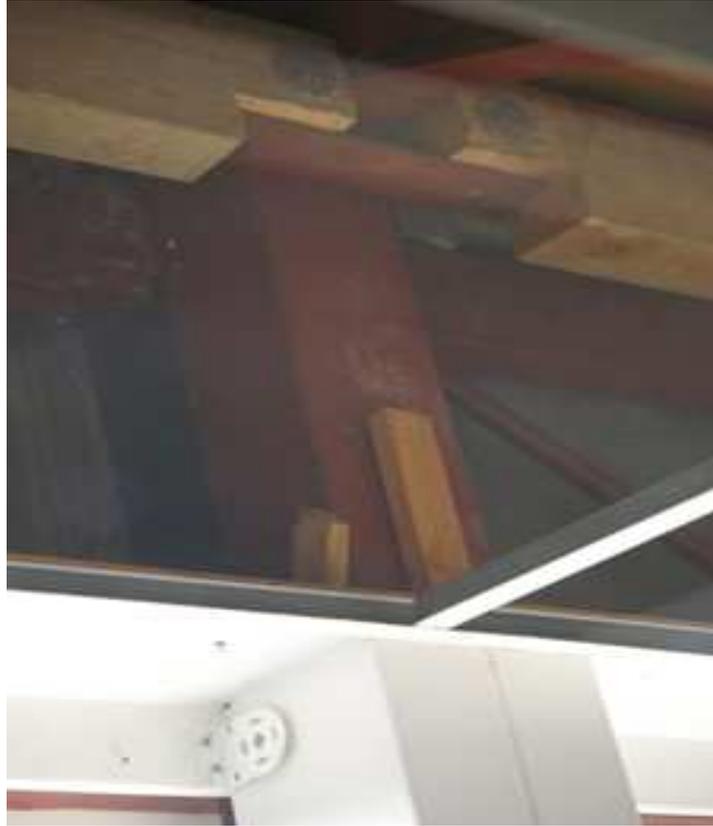
**Plate 13: Column Casing and Cladding Open at Ceiling Void**

Note: CLASP Mk4. The ceiling tiles have been removed for access. The top of the white column cladding just protrudes into the ceiling void. The wooden wedges hold the AIB cladding in place. The air gap between the column and the AIB cladding vents freely into the void at the top of the photograph and the bottom.
